# FURNACE CONVEYOR REBUILD

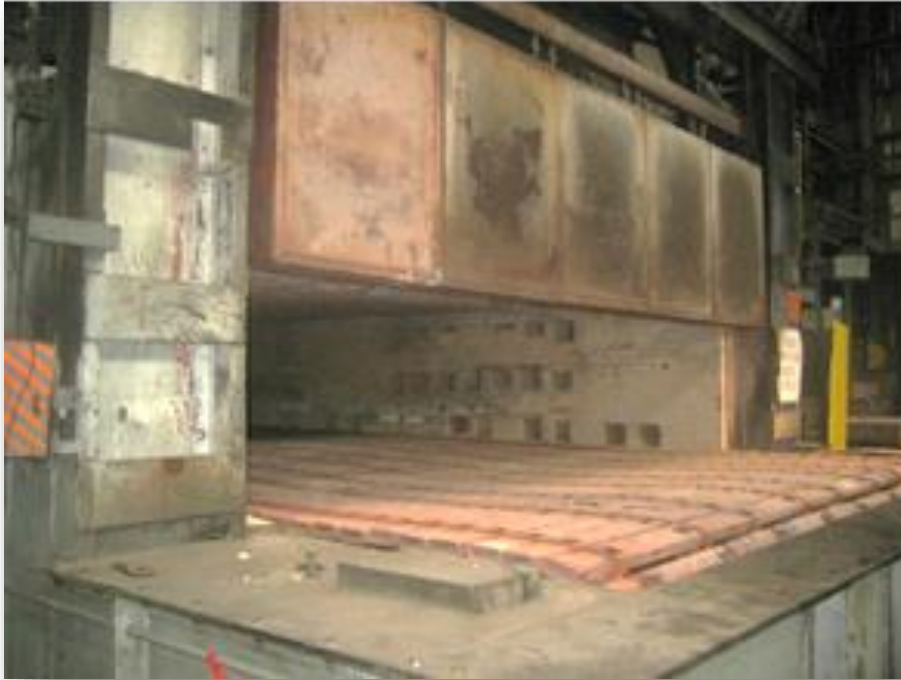
*Furnace entrance before the rebuild.*

**Problem:** Loose slats on a conveyor furnace would jamb the conveyor drive and cause damage to the furnace interior. Unscheduled downtime disrupted production schedules for the customer. In addition the slat chain channels were deformed due to inadequate structural support (*see the bow in the picture above*).

**Solution:** PTS redesigned the furnace slats with an improved attachment which was easier to install and maintain while providing a loose fit to allow the slats to expand and contract with the repetitive temperature cycles of the furnace. In addition, the number of attachment points was doubled to prevent a slat from coming off if one bolt failed.

The slats attach to a roller chain which is supported by structural steel channels. Over time and hard use, the channels became deformed by the loading and unloading at the entrance/exit ends of the furnace. The channels were replaced and additional structural support was designed to provide a more robust structural system. The drive sprockets were also aligned during the rebuild.
