# 35' ROTARY FURNACE REPAIR

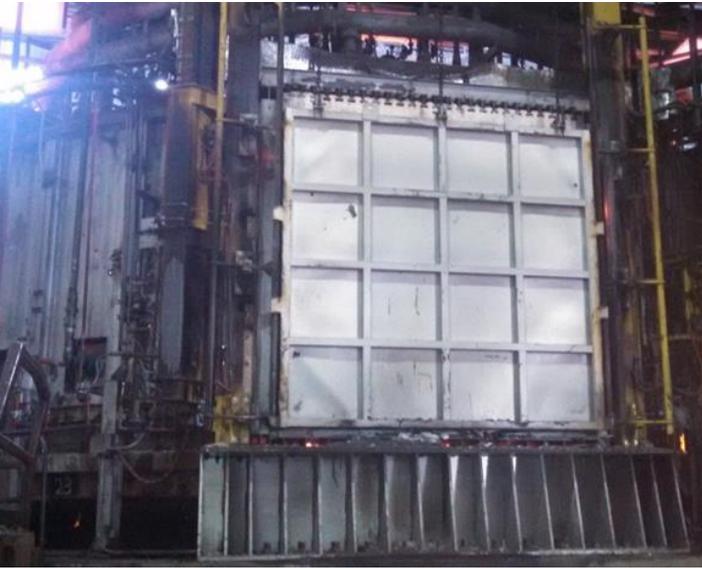
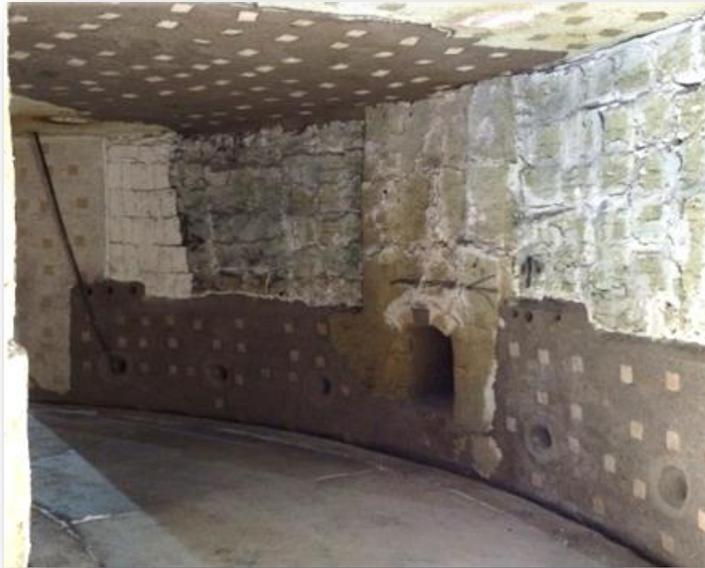
(Above: Furnace with discharge door closed / Right: Inside with completed repairs)

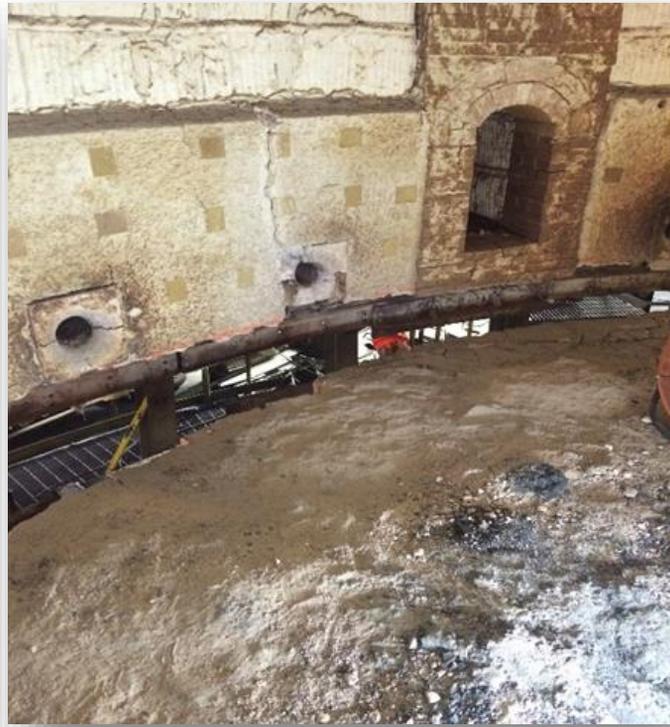
*Right: Shown with wall castings, water troughs, retaining ring and water seal blades removed.*

PTS's goal was to develop a scope of work that met the owner's repair requirements, improved furnace reliability, and could be completed within the scheduled shutdown period. The initial scope consisted of replacing: inside and outside water troughs, knife blades, retaining rings, hearth centering bearings, entire roof refractory, door sills & plate, furnace doors, door columns & beam door support, and substantial refractory repairs.

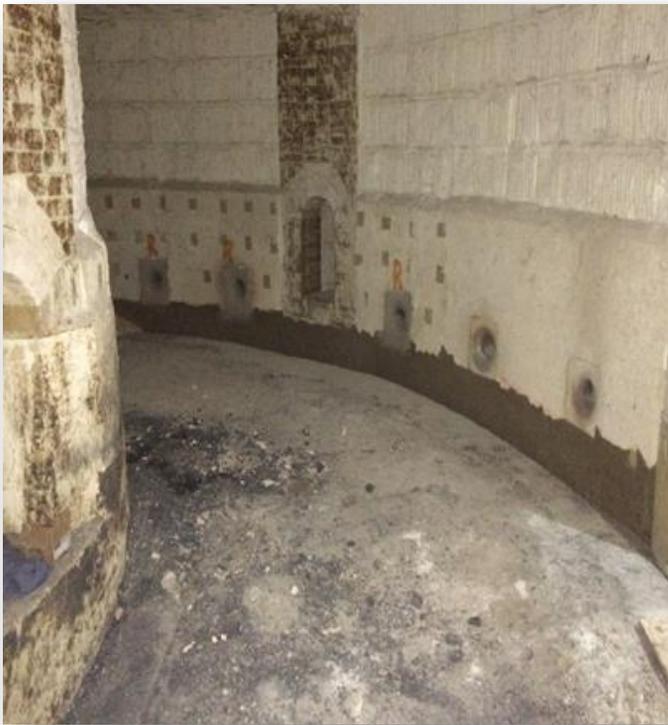
*Left: Repairs to hearth and lower wall after installation of new wall castings and water troughs.*

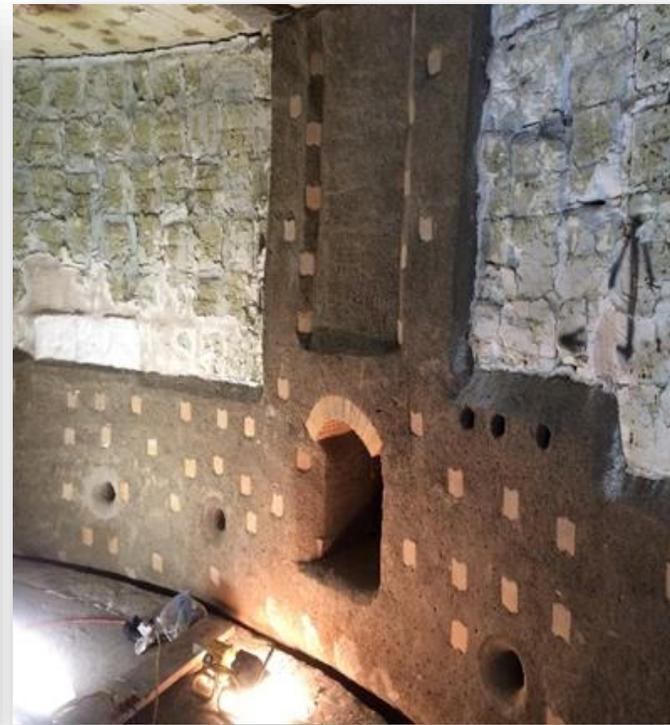
*Right: New flue, perimeter sidewall and hearth floor.*
